4. TITLE (and Subtitle)  Lower Eddy Pond Dam NATIONAL PROGRAM FOR INSPECTION OF NON-FEDERAL DAMS		5. TYPE OF REPORT & PERIOD COVERED INSPECTION REPORT
7. AUTHOR(s) U.S. ARMY CORPS OF ENGINEERS NEW ENGLAND DIVISION		6. PERFORMING ORG. REPORT NUMBER

20. ABSTRACT (Continue on reverse side if necessary and identify by block number)  ➤The dam is an earth embankment with a length of 250 ft. and is 20 ft. high. The dam appears to have had little or no maintenance in recent years. The condition of the dam is in very poor. It is small in size with a high hazard potential. A major breach of the dam could cause appreciable damage to property and loss of a few lives in the downstream area. There are various remedial measures and recommendations which are to be undertaken by the owner.

# **LOWER EDDY POND DAM**

**RUTLAND, VT.**

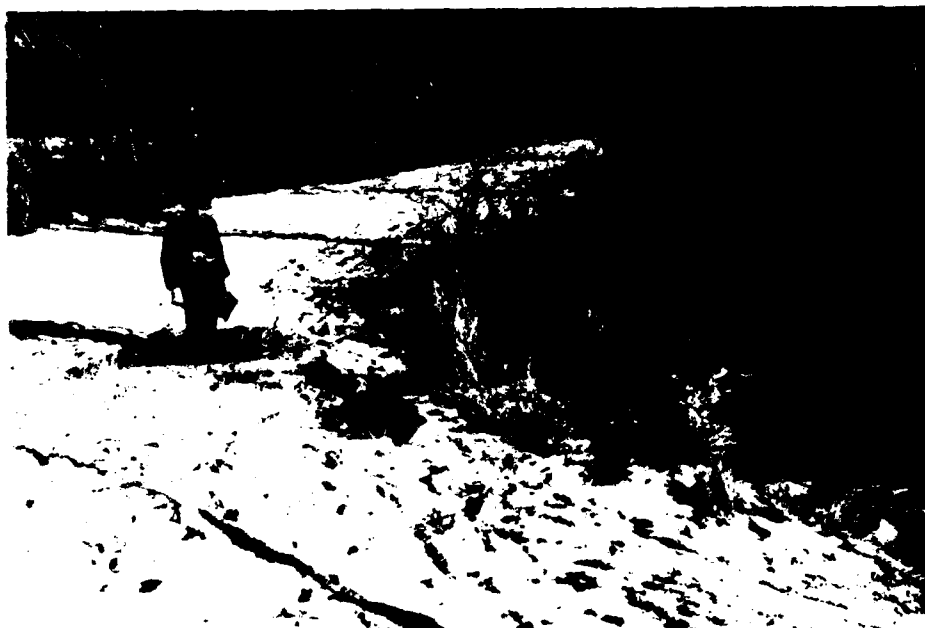
The dam is showing signs of serious internal erosion by piping as evidenced by a 2-foot diameter, 1-foot deep sink hole on the crest located approximately 180 feet west of the center of the spillway (see Photographs 5 and 6, Appendix C). The piping condition is further manifested by a collapsed area at the upstream face of the dam opposite the sinkhole where a flow of water can be seen entering the embankment (see Photograph 8, Appendix C). Water can be observed exiting from collapsed and undermined areas at the downstream slope approximately 140 feet west of the center of the spillway (see Photograph 11, Appendix C). (The exiting flow rate was visually estimated to be between 25 and 50 gallons per minute.) Fine grained soil deposits are visible in areas where the flow emerges from the dam embankment (see Photograph 12, Appendix C).

The sides of the sink hole show bare earth which indicate that this is an active feature. The owners' representative stated that the sink hole had not been noted during summer of 1980.

Photograph 5 - View of 2-foot diameter, 1-foot deep sink hole on crest of dam (Photograph 6) and collapsed area on upstream face (Photograph 8). Excavated area in front of sink hole is man made.

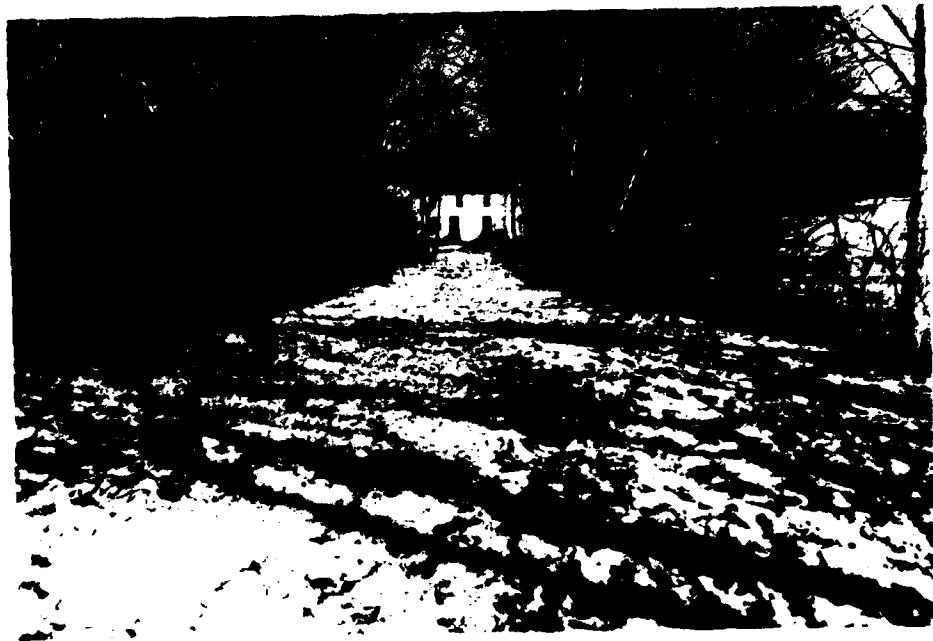
The failed concrete spillway is now an obstruction to flows passing over the ledge outcrop at the easterly abutment and erosion of the embankment is progressing from the spillway in a westerly direction. There are several large trees on the embankment, some of which are leaning. Should these trees become uprooted and fall over, a breach in the embankment could result. Fallen trees could also obstruct flow at the damsite. The presence of animal burrows are a further threat to the earth embankment.

Photograph 1 - Crest looking east. Note large leaning trees on both upstream and downstream slopes.
